Property Inspection Report

Client(s): **David Huston and Melissa Lee**

Property address: **4911 Brand Way**

Inspection date: **Tuesday, November 12, 2019**

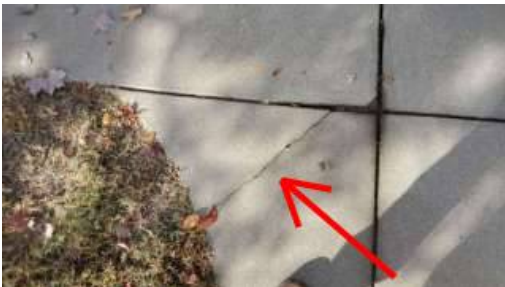
Photo 4-1

5) Small shrinkage cracks noted in front porch / patio area. These cracks appear to be typical shrinkage cracks and do not indicate a structural issue.

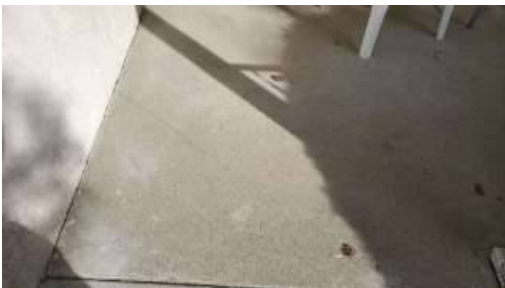
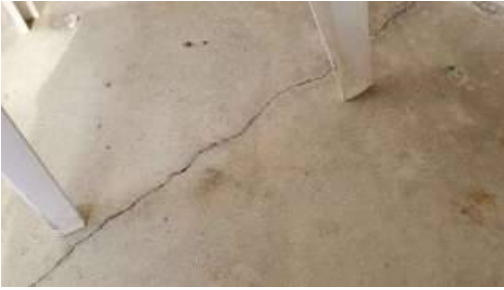
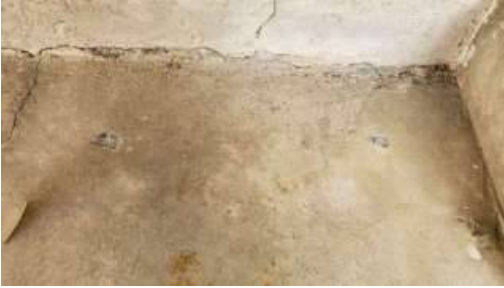
Concrete drilling for termite treatment noted. See Structural Pest Control Report for details.

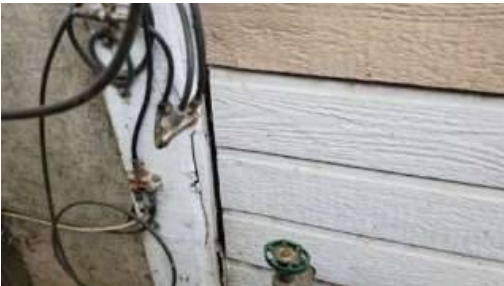
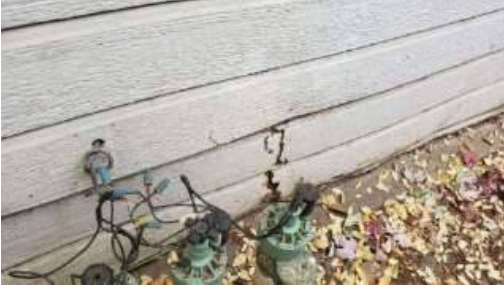
Many sections of siding and/or trim were deteriorated. Recommend that a qualified person repair, replace or install siding or trim as necessary.

See structural pest control report for details.

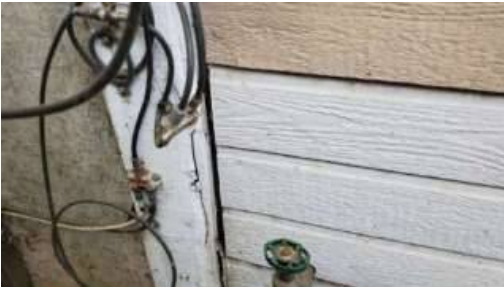
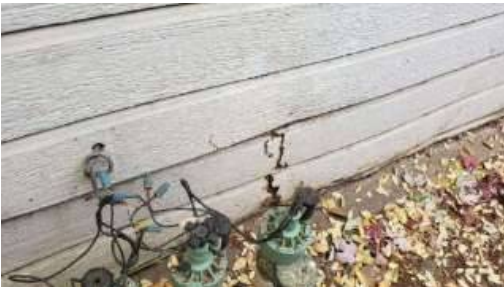
This property was clad with composition wood-fiber siding. Various manufacturers (e.g. Louisiana Pacific, Weyerhaeuser and Masonite) have produced this type of siding, which is made from oriented strand board (OSB) or "hardboard." It is prone to deteriorate and/or fail prematurely due to moisture penetration, especially when the paint coating is substandard or has not been maintained. Failure is typically visible in the form of swelling, cracking, buckling, wafer pops, delamination and fungal growth.

Some areas of siding on this structure showed symptoms described above and need replacement and/or maintenance. Some manufacturers (e.g. Louisiana Pacific) recommend a repair process for this siding where affected areas are sealed with Permanizer Plus, a flexible primer made by Pittsburgh Paint, followed by two coats of 100% acrylic latex paint. This sealant must be applied to the bottom edges using a brush. The face of the siding can be sprayed. The Permanizer Plus sealer isn't required for edges that aren't swollen, cracked or deteriorated, but the acrylic latex should still be brushed on these edges.

Recommend that a qualified contractor evaluate and replace siding as necessary, and/or seal and repaint as necessary. Repairs should be made per the siding and/or sealant manufacturer's installation instructions, and per standard building practices.

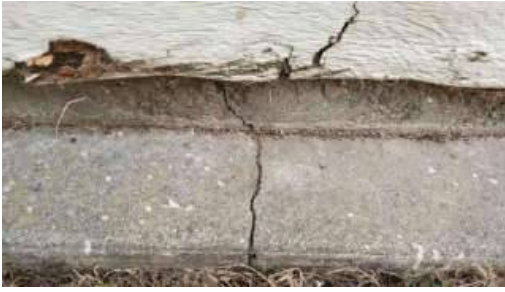
Photo 8-1

One or more minor cracks (1/8 inch or less) were found in the foundation. These didn't appear to be a structural concern, but recommend sealing them to prevent water infiltration and monitor them in the future. Numerous products exist to seal such cracks including hydraulic cement, non-shrinking grout, resilient caulks and epoxy sealants.

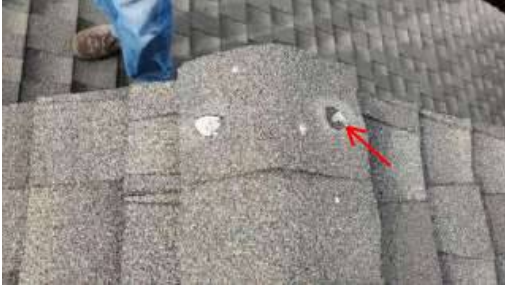
Photo 12-1

Nail heads were exposed at one or more shingles. More than just a few exposed nail heads may indicate a substandard roof installation. Recommend applying an approved sealant over exposed nail heads now and as necessary in the future to prevent leaks.

Noted in typical end of ridge run locations. Partially exposed. Could use a touch up of roofing mastic or 100% silicone now, and every few years as a maintenance item.

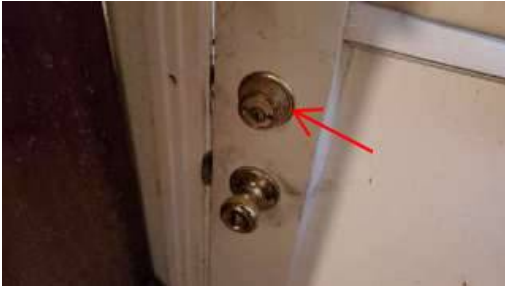
Photo 14-1

The garage exterior man door has a double-sided deadbolt lock installed. This is an egress door and must have a thumbscrew deadbolt attached for easy egress from the building in the dark.

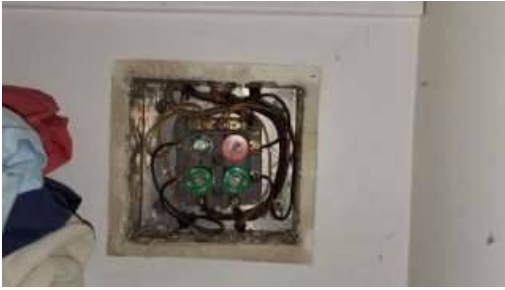
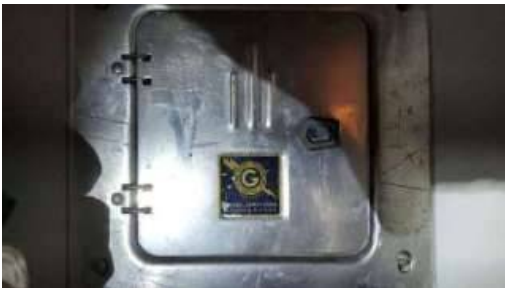
Panel(s) #B used screw-in fuses for the over-current protection devices. Fuses are prone to tampering and over-fusing, which can damage wiring and cause fire hazards. Insurance companies may deny coverage for homes with fused panels. Modern panels use circuit breakers for over-current protection devices, which can be reset easily after tripping rather than needing to replace fuses. Modern panels also offer more flexibility for new, safer protective technologies like ground fault circuit interrupters (GFCIs) and arc fault circuit interrupters (AFCIs). Consult with a qualified electrician about replacement options for fused panels, and about other system upgrades as necessary.

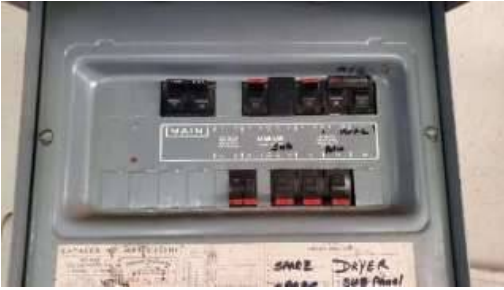
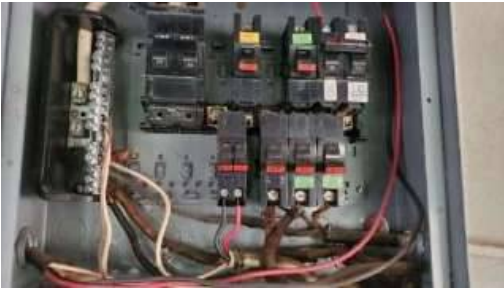
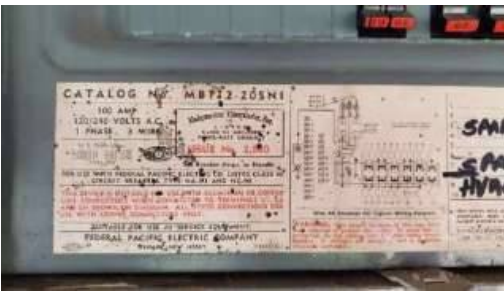
Panel(s) #A were manufactured by the Federal Pacific Electric company and used "Stab-Lok" circuit breakers. There is significant evidence that both double and single pole versions of these circuit breakers fail by not tripping when they are supposed to. However, in 2011 the Consumer Products Safety Commission (CPSC) closed an investigation into this product because they did not have enough data to establish that the circuit breakers pose a serious risk of injury to consumers. Regardless, and due to other evidence of safety issues, recommend that a qualified electrician carefully evaluate all Federal Pacific panels and make repairs as necessary. Consider replacing Federal Pacific panels with modern panels that offer more flexibility for new, safer protective technologies like ground fault circuit interrupters (GFCIs) and arc fault circuit interrupters (AFCIs). For more information, visit:

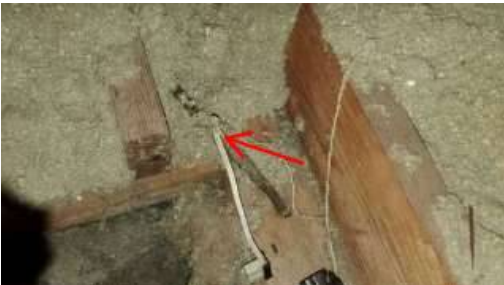
Photo 21-1

Substandard wiring was found at the attic. For example, exposed splices. This is a safety hazard. Recommend that a qualified electrician evaluate and repair as necessary and per standard building practices.

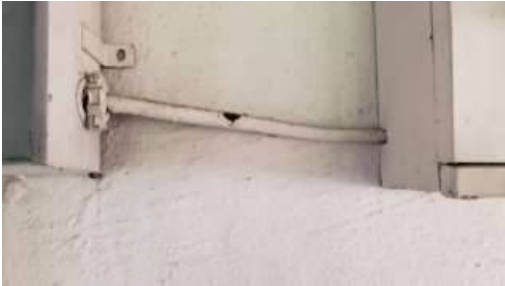
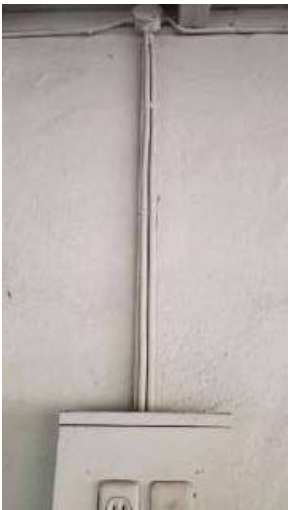
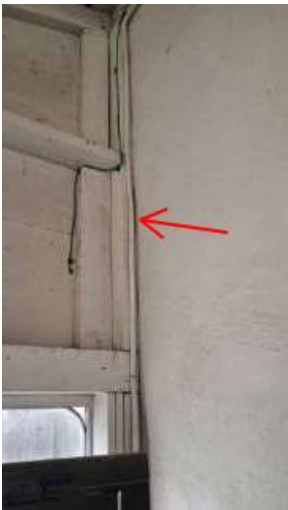
Non-metallic sheathed wiring was installed at one or more locations, and was subject to damage such as on easily accessible wall or ceiling surfaces. The insulation can be damaged by objects coming in contact with it, resulting in exposed, energized wires. Also, copper conductors can break after being repeatedly moved or bent. This is a potential shock or fire hazard. Recommend that a qualified electrician repair per standard building practices. For example, by installing protective conduit or re-routing wires through walls or ceilings.

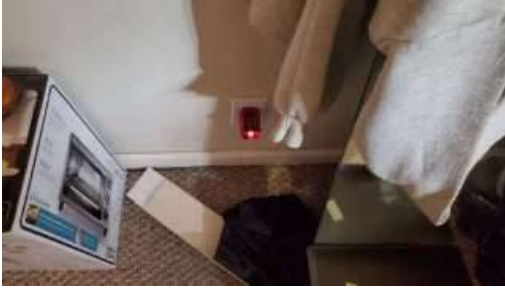
Photo 26-1

One or more modern, 3-slot electric receptacles (outlets) were found with an open ground. Three-slot receptacles should have a hot, a neutral and a ground wire connected. Homeowners often install new 3-slot receptacles on older, 2-wire circuits that only have hot and neutral wires. This is a shock hazard when appliances that require a ground are used with these receptacles. Examples of such appliances include computers and related hardware, refrigerators, freezers, portable air conditioners, clothes washers, aquarium pumps, and electrically operated gardening tools. Where the electric system was installed prior to when grounded circuits were required (1960s), it is permissible to replace 3-slot receptacles with 2-slot receptacles to prevent appliances that require a ground from being plugged in to an ungrounded circuit. However, the client should be aware of this limitation when planning use for various rooms, such as an office. For newer electric systems, circuits should be repaired so grounded, 3-wire cables provide power to 3-slot receptacles. Recommend that a qualified electrician repair per standard building practices.

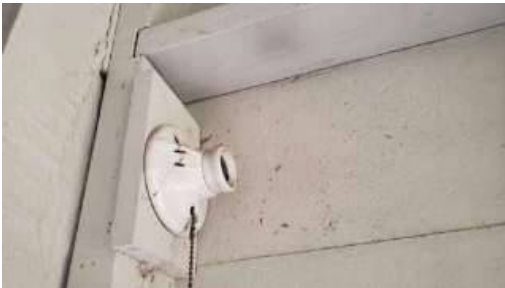
Photo 30-1

30) The "keyless" light fixture in the covered porch was installed without a junction box.

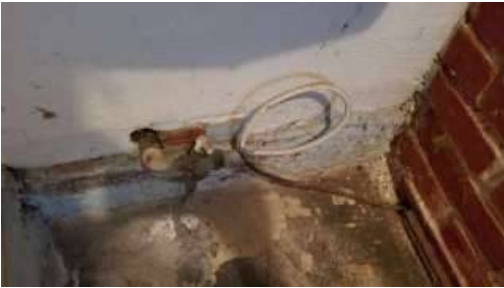
Photo 31-1

One or more flexible gas supply connectors were installed where they were subject to damage. For example, from foot traffic, stored items being moved, pets, or use of gardening tools. This is a potential explosion and/or fire hazard. Recommend that a qualified contractor repair per standard building practices.

Noted at the supply for the make shift log lighter in the fireplace where it passes through the garage wall.

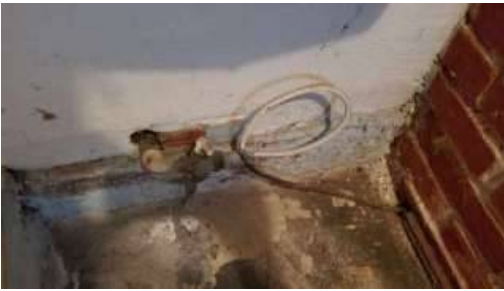
Photo 32-1

One or more flexible connectors used for gas supply lines passed through a wall. Flexible connectors passing through walls, floors, ceilings, shelving or cabinets can be damaged, and leaks can occur. This is a potential explosion and/or fire hazard. Recommend that a qualified contractor repair per standard building practices.

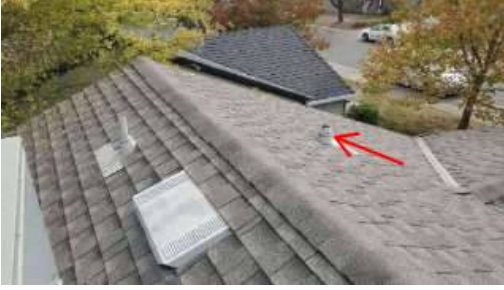
Photo 34-1

One or more plumbing vent pipes terminated less than 6 inches above the roof surface below. Debris and/or snow can block vent pipe openings with such short pipes. Blocked vent pipes can cause sewer gases to enter living spaces. Recommend that a qualified person repair per standard building practices. For example, by extending pipe(s) to terminate at least 6 inches above the roof surface.

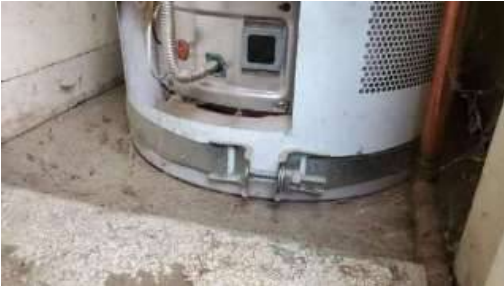
Photo 35-1

The water heater's earthquake straps or struts were substandard. For example, they may allow significant movement or use substandard fasteners. This is a potential safety hazard in the event of an earthquake due to the risk of the water heater tipping over, gas lines breaking if it's gas-fired, or electric wiring being damaged if powered by electricity. Leaks can also occur in water-supply pipes. Recommend that a qualified person repair or replace existing earthquake reinforcement per standard building practices.

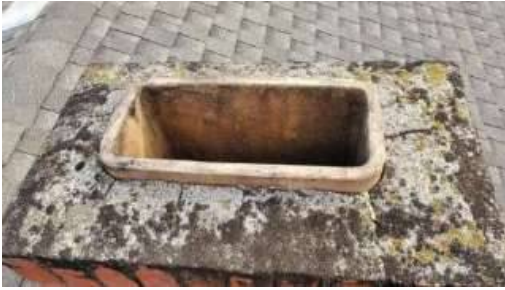
Photo 39-1

No spark screen or rain cap was installed at one or more chimney flue terminations. Spark screens reduce the chance of embers exiting the flue and causing fires. They also prevent wildlife (e.g. birds, rodents, raccoons) from entering flues. Rain caps prevent water from entering flues, mixing with combustion deposits and creating caustic chemicals which can corrode flues. They also prevent damage to masonry from freeze-thaw cycles and prevent metal components (e.g. dampers, metal firebox liners) from rusting. Recommend that a qualified person install rain caps with spark screens per standard building practices where missing.

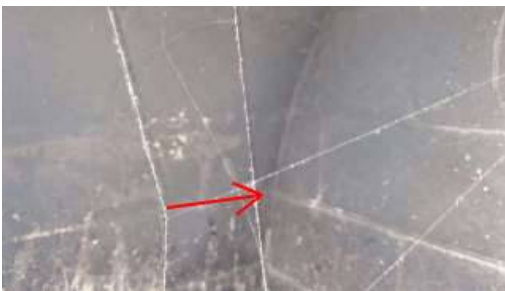
Photo 41-1

The fireplace's firebox was slightly deteriorated. For example, loose, cracked, pitted or broken firebricks, gaps between bricks and/or missing mortar. Heat from the fireplace may penetrate the firebox. This is a potential fire hazard. Recommend that a qualified contractor repair as necessary.

Mortar missing in the right back / wall joint.

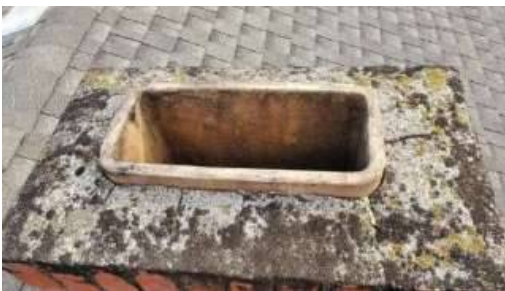
Photo 43-1

One or more masonry chimney crowns were worn. Crowns are meant to keep water off of the chimney structure and prevent damage from freeze-thaw cycles. Chimney crowns are commonly constructed by mounding concrete or mortar on the top chimney surface, however this is substandard. A properly constructed chimney crown should:

- Be constructed using either precast concrete slabs, cast-in-place steel reinforced concrete, solid stone, or metal
- Be sloped down from the flue a minimum of 3 inches of fall per foot of run
- Extend a minimum of 2 1/2 inches beyond the face of the chimney on all sides
- Not directly contact the flue liner (if installed), with the gap filled with flexible caulk
- Have flashing installed between the bottom of the crown and the top of the brick chimney

Recommend that a qualified contractor repair or replace crowns as necessary, and per standard building practices.

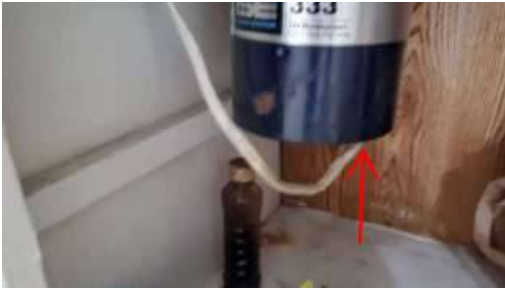
Photo 44-1

Electrical wiring for the under-sink food disposal was substandard. Non-metallic sheathed wiring was exposed and subject to damage. The wiring can be damaged by repeated bending or contact with sharp objects. BX-armored conduit should be installed to protect wiring, or a flexible appliance cable should be installed. This is a potential shock hazard. Recommend that a qualified contractor repair per standard building practices.

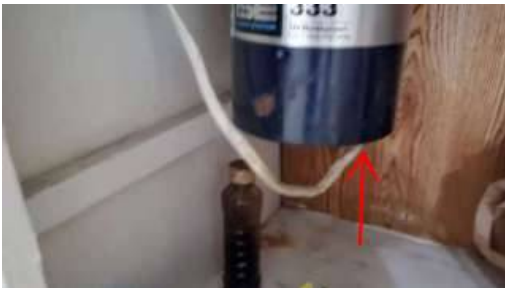
Photo 45-1

One or more bushings were missing for the under-sink food disposal's electric wiring. Insulation on the wiring can get damaged where wires are routed through holes in the under-sink food disposal's metal housing. This is a potential shock hazard. Recommend that a qualified electrician install bushings where missing and per standard building practices.

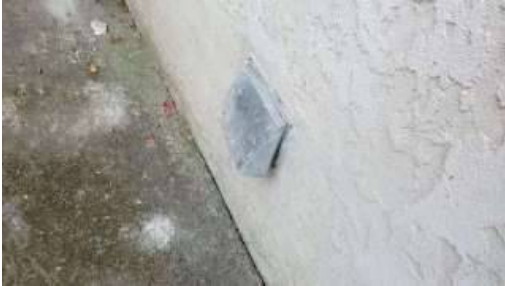
Photo 47-1

The clothes dryer exhaust duct was kinked, crushed or damaged. Air flow will be restricted as a result and the clothes dryer may overheat. This is a safety hazard due to the risk of fire. Recommend that a qualified person replace or repair the duct as necessary. For more information, visit: <http://www.reporhost.com/?DRYER>

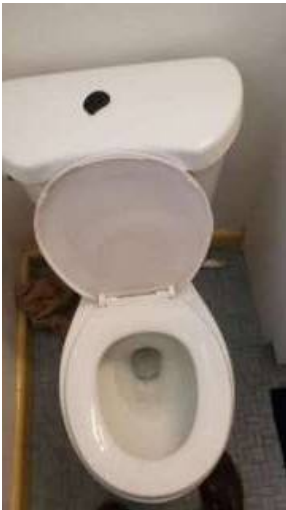
Photo 48-1

The toilet at location(s) #A was loose where it attached to the floor. Leaks can occur. Flooring, the sub-floor or areas below may get damaged. Sewer gases can enter living spaces. Recommend that a qualified contractor remove the toilet(s) for further evaluation and repair if necessary. A new wax ring should be installed and toilet(s) should be securely anchored to the floor to prevent movement and leaking.

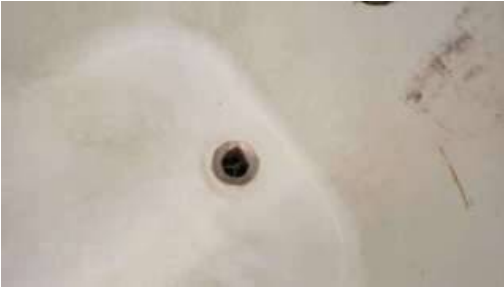
Photo 52-1

The bathtub at location(s) #A drained slowly. Recommend clearing drain and/or that a qualified plumber repair if necessary.

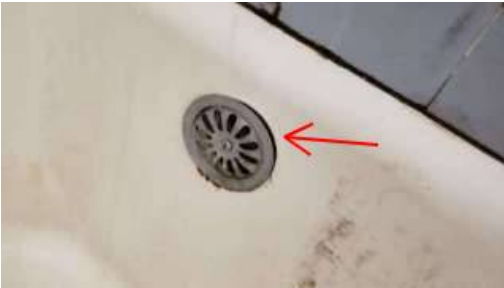
Photo 53-1

53) Bathtub overflow seal is deteriorated and loose which allows water to enter behind the tub and into the subarea. Wood deterioration and active leak noted in sub area.

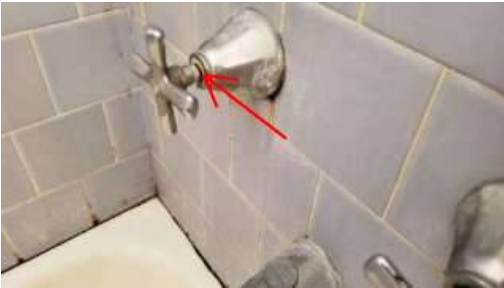
Photo 54-1

54) The hot water bathtub valve stem leaks when in the on position. Leak is contained by the bathtub.

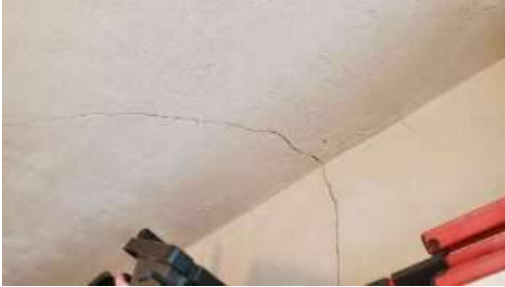
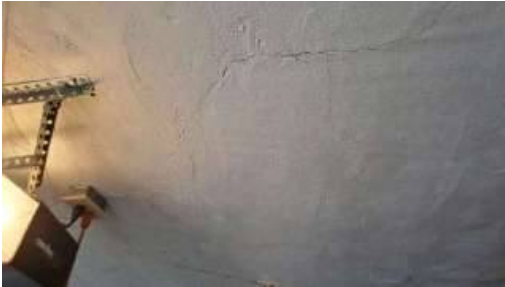
Minor cracks, nail pops and/or blemishes were found in walls and/or ceilings in one or more areas. Cracks and nail pops are common, are often caused by lumber shrinkage or minor settlement, and can be more or less noticeable depending on changes in humidity. They did not appear to be a structural concern, but the client may wish to repair these for aesthetic reasons. For recurring cracks, consider using an elastic crack covering product: <http://www.reporhost.com/?ECC>

Minor plaster cracking noted in garage.
